US Army Corps
of Engineers®

Coastal Barrier Island Breaching, Part 2: Mechanical Breaching and Breach Closure

by Ty V. Wamsley and Nicholas C. Kraus

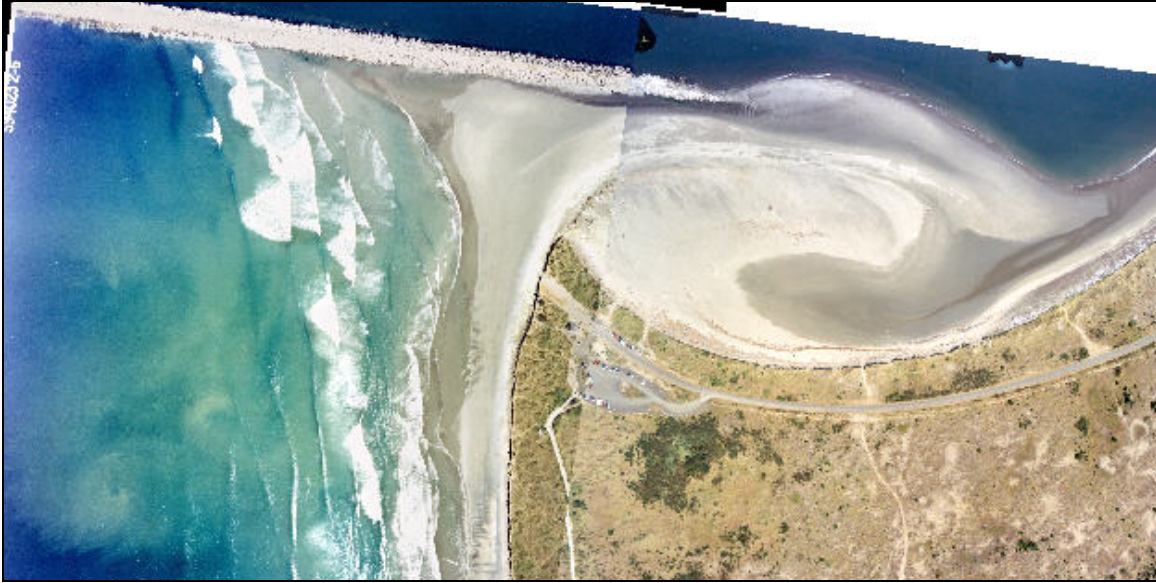
Figure 7. Grays Harbor, WA, breach area

a. Before closure, August 1994

b. After closure, September 1995. Closure was completed in December 1994

The sand was pumped unconfined on the upland adjacent to the breach and stockpiled until a sufficient volume was available to close the breach. The breach was closed by bulldozing the stockpiled material into the narrowest part of the breach. The closure operation began around low tide, and the initial closure was completed by high tide. The sand was pushed from the beach, across the breach toward the jetty. Maximum current velocity through the breach at the time of closure was about 2 m (6.5 ft) per sec, but there was little flow through the breach at low tide. With the initial fill cross section in place, the same technique was applied to complete the fill to the final design template. The breach fill was completed on 7 December 1994 with 458,732.9 cu m (600,000 cu yd) of sand dredged from the navigation channel. Photographs in Figure 7 show the breach area before and after closure.

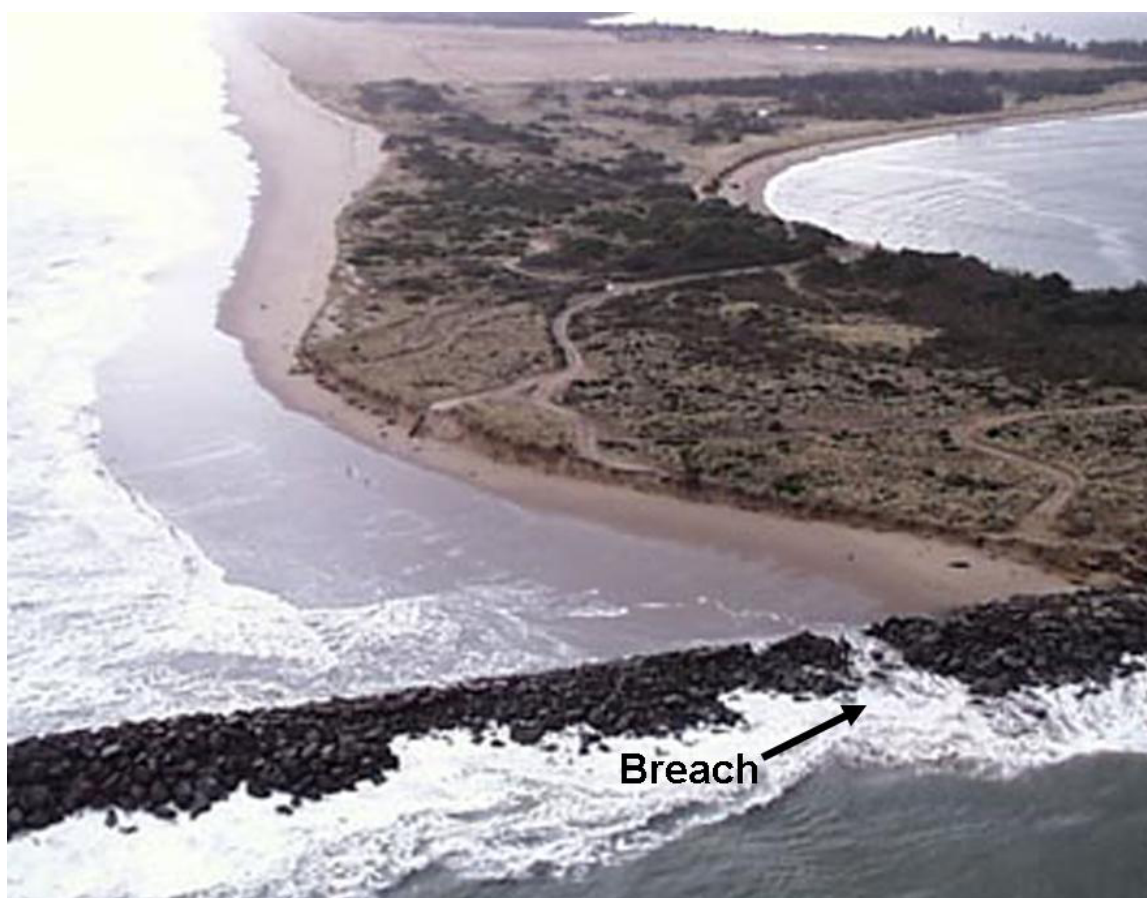
Figure 8. Coos Bay, OR, breach of north jetty (Hays et al. 2003)

Following the breach, the beach adjacent to the north jetty eroded, losing an estimated 30,582.1 cu m (40,000 cu yd) of sand through the breach and into the entrance. The beach profile elevation was lowered approximately 75 m (6.5 ft). Tidal flow through the breach widened the damaged area in the weeks following the storm. Approximately 40 days after the jetty breached, the opening had widened from an initial 4-m (13-ft) width to about 245 ft. The jetty breach caused rapid shoreline recession and, if not closed, could have resulted in a breach of the barrier spit.

Because of the continued damage to the jetty and the transport of sediment through the jetty and into the navigation channel, the U.S. Army Engineer District, Portland, initiated the coordination of an emergency repair on 25 November 2002. Construction began on 20 December 2002, and the repair was completed on 9 January 2003. The jetty was restored to the 1939 design cross section with slightly larger stone to improve structure stability. A jetty “bench” was also constructed along the structure to protect the foundation from return flow scour. The bench is a rubble mound constructed perpendicular to the jetty on the beach side to an elevation of +3 m (+9.8 ft) mllw and 6.1 m (20 ft) wide. The jetty repair also included a 38,227.7-cu m- (50,000-cu yd-) sand fill in the eroded area adjacent to the jetty breach. The fill replaced the sand lost through the breach and advanced the shoreline seaward of the repair area. The fill buried the bench and provides protection to the jetty root. The jetty has not sustained damage since the repair.

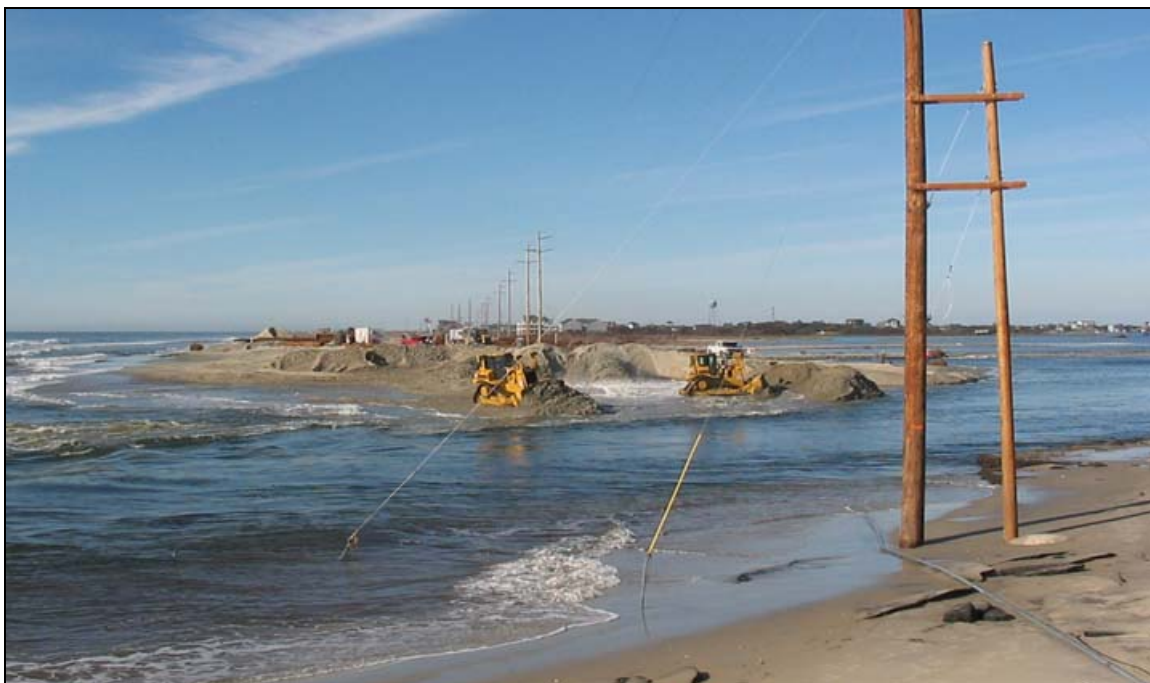
Figure 9. A view of first attempt to complete closure looking to west from eastern bank of breach (Wutkowski 2004)
